Vancouver Public Tennis Courts Structure Report

Central courts 2

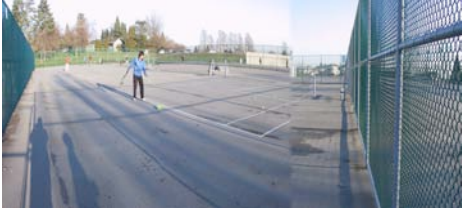
<p>Queen Elizabeth Park Surface: asphalt Rating: 3 & Type 4 Painted: 1 yes, 16 no # of courts: 17 Status: Serious cracks and heaves on various courts, to the point of creating dangerous footing (see courts 12 and 13). Despite being very well used, these courts have been neglected in terms of maintenance/ repair. Courts 10-16 are a public embarrassment and should be a top priority for repair. Park Board has recently put up some new nets, and patched and painted court 9 as a "pilot project". Pilot project? Courts 1, 2, 5, 6 would be ideal location for lights, as no direct neighbours, and players use these courts nearly year round.</p>

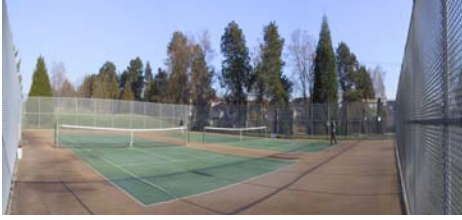
<p>Langara Surface: asphalt Rating: 1 & Type 3 Painted: yes # of courts: 4 Status: Courts are relatively newly resurfaced. No cracks and well taken care of by the regular users.</p>

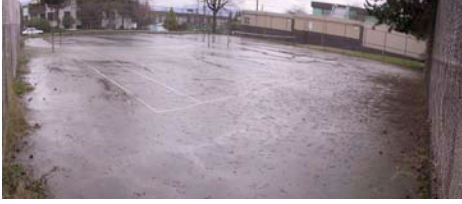
<p>Guelph Surface: asphalt Rating: 3 & Type 4 Painted: no # of courts: 2 Status: Small cracks, no root invasion. Sand comes onto courts from the playground.</p>
