Vancouver Public Tennis Courts Structure Report

East Side courts 2

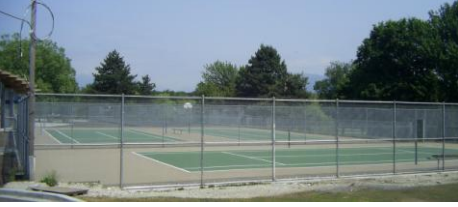
<p>Humm Park Surface: asphalt Painted: no Status: Cracks on all courts.</p> <p style="text-align: right;">Rating: 3 & Type 4 # of courts: 2</p>

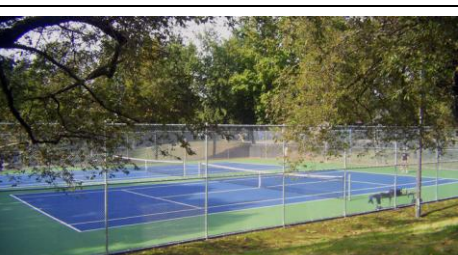
<p>Kaslo Park Surface: asphalt Painted: no Status: No cracks, but very rough surface. Can be dangerous to play on. Located in a residential neighbourhood. Has potential to be very good courts if maintained.</p> <p style="text-align: right;">Rating: 2 & Type 4 # of courts: 2</p>

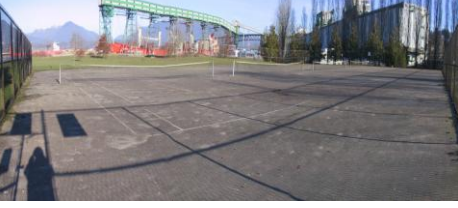
<p>McSpadden Surface: asphalt Painted: yes Status: Refurbished in 2008. Nice courts with centre strap nets. There is a practice wall, but facing the back of one court – cannot be used unless no one is playing!!!!</p> <p style="text-align: right;">Rating: 1 & Type 3 # of courts: 2</p>

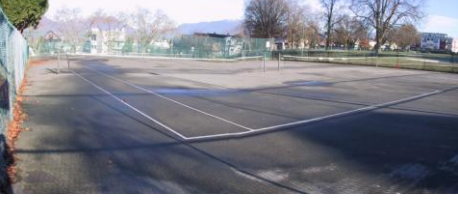
<p>New Brighton Surface: asphalt Painted: no Status: No cracks or trees, but courts in desperate need of painting and upkeep. Location is hard to find, down there under the Second Narrows Bridge. No parking available after the summer.</p> <p style="text-align: right;">Rating: 2 & Type 4 # of courts: 4</p>
